The white etching cracking phenomenon: how to minimise it and keep your wind turbines turning

1. Introduction

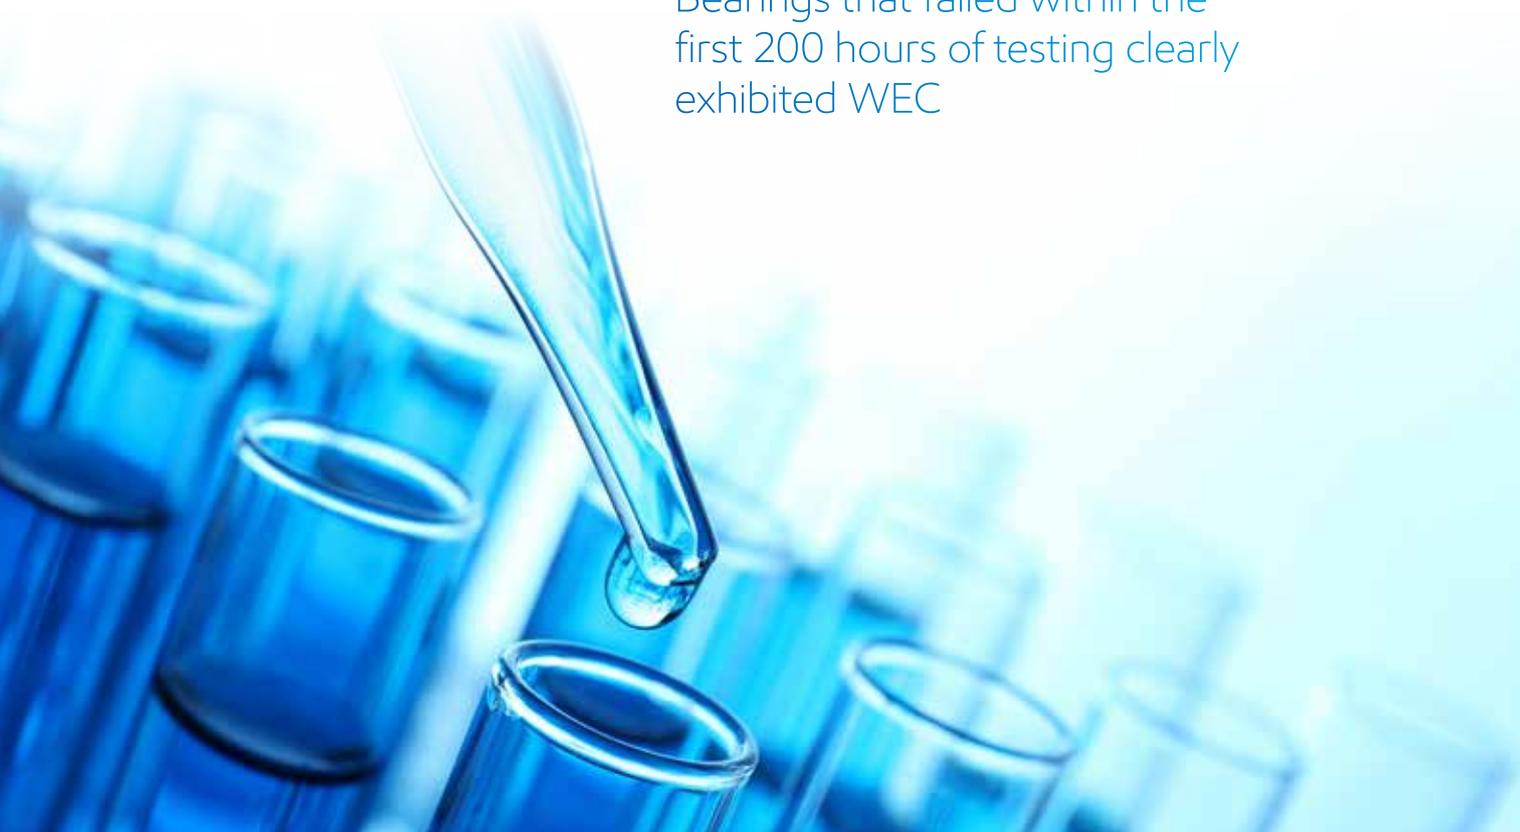
Bearings that failed within the first 200 hours of testing clearly exhibited WEC

Bearings that failed within the first 200 hours of testing clearly exhibited WEC, defined by the characteristic white area adjacent to the crack. No such signs were observed in specimens of bearings that lasted longer than 200 hours of FE8
